## SISO internal test.

Test subject	:	15.06.290-0 + 15.06.291-0
Standard	:	Internal
Ordered by	:	DTP
Done by	:	AS
Purpose	:	Stress test of hinge.

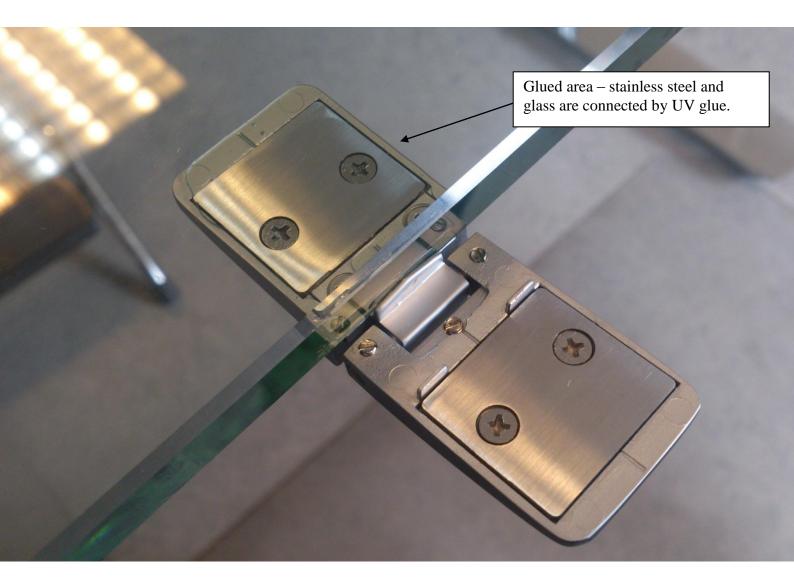
The hinge is glued onto a 12 mm. glass plate – picture below shows the result. The curing of the glue has been done by an appropriate UV light – wave length nm 380

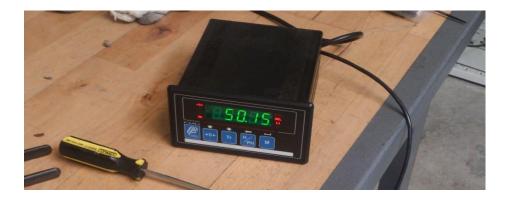
After pulling with a force of 50 kg. the hinge is still intact and no deformation, noises or changes within the function of the hinge are to be detected. The test stopped as we reached 50 kg. as this is the pull force limit.

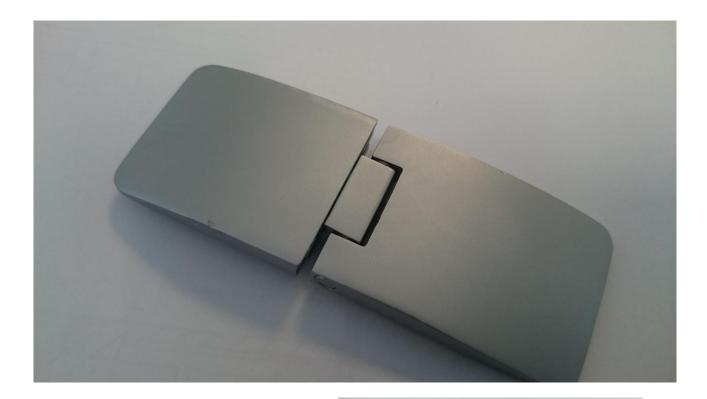
Pictures show the hinge after the test:

Dents / marks came from removing the hinge off the glass sheet. (done by hammer)
