12.10.256 Internal Pull out test

Internal Test

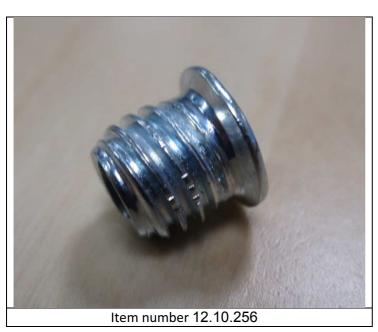
Test layout

Hole diameter [mm]	Ø9,5mm (see notes in appendix section)
Class of wood	
Test tool	Lifter, Round head screw 8.8 M6x50, heavy washer

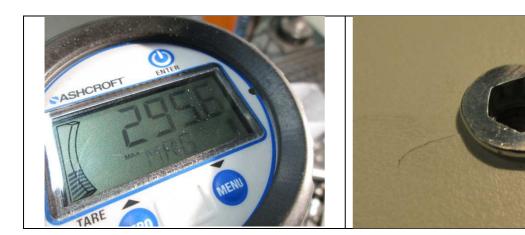
Test Results

Sample	Results
12.10.256	295,6 Kg [2900 Newton]

Comments: cracks in panel due to high tension value. No problem with manual insertion. Great stability after screwing action.

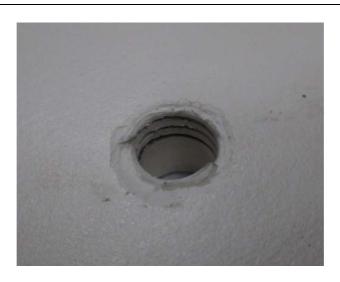
Picture - 2 - Cracks (Ø9,0 test)

Test was initially performed with \emptyset 8,5mm and \emptyset 9,0mm holes. Results were not collected because the panel was damaged and the screwing action was not possible.
